No.83 ENERGY PACK

No. 89-24 ENERGY PACK

TROUBLESHOOTING Nos. 83, 89, 89-12, 89-24

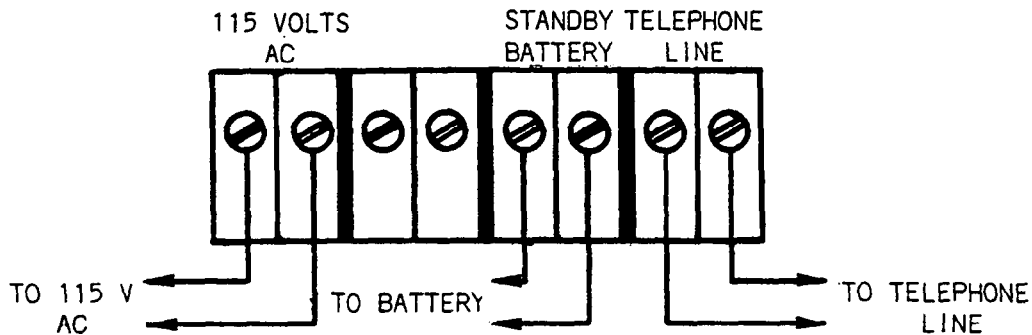
Energy Pack 89-24 supplies power for telephone line circuits and provides completely adjustable voltage from 0 to 24 Volts. It is not suitable for bell ringing circuits, as the current is deliberately limited to protect telephone lines.

To install the No. 89-24, follow these steps in order. Step 3 may be omitted if standby battery is not required.

1. Before connecting any wires, remove chrome plug and by means of a screwdriver, turn the voltage adjusting control fully counterclockwise.
2. Connect the proper terminals in the control instrument or central office relay to the terminals marked "TELEPHONE LINES".

3. If standby battery is desired, add sufficient batteries so that the proper current flows over the line.
4. Connect the terminals marked "115 volts A.C." to a reliable 110-120 volt A.C. source. The voltage at the telephone line terminals will now be zero.

5. Slowly turn the control clockwise until the proper current flows over the telephone line. All Ademco Modularms, Mini-modularms and the No. 121 Police Alarm strips require 4 Milliamperes of current flowing over telephone line. When the voltage adjusting control is properly adjusted, the meter on the No. 130 Modularm plug-in unit at headquarters will read in the green area. For specific recommendations on adjustment procedure, see "No. 89-24 ADJUSTMENT PROCEDURE" found on page 21 of Section N in this manual.

Note: Unless the above procedure is followed, damage is sure to result to components, as excessive current may flow over the line.
